STEERING PAD

COMPONENTS

ON-VEHICLE INSPECTION

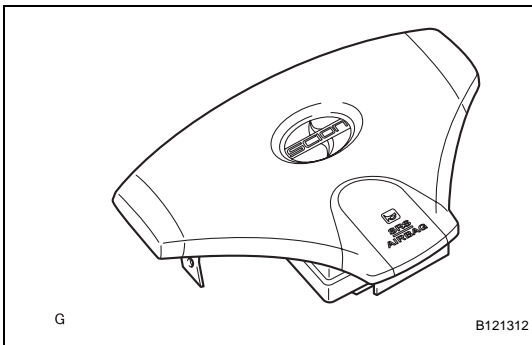
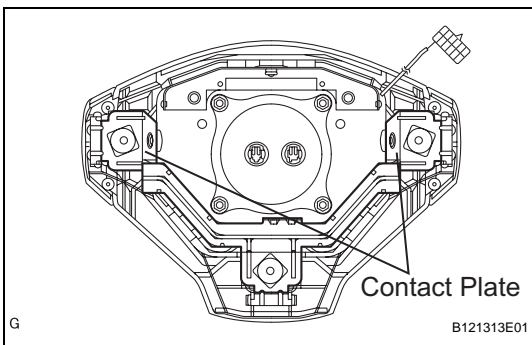
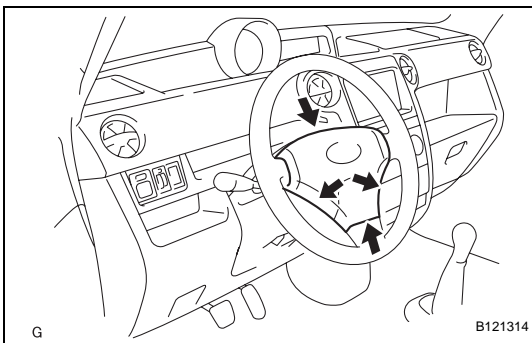
2. CHECK STEERING PAD ASSEMBLY (VEHICLE INVOLVED IN COLLISION AND AIRBAG NOT DEPLOYED)

- (a) Perform a diagnostic system check (see page [RS-24](#)).
- (b) With the steering pad (with airbag) removed from the vehicle, perform a visual check:
 - Check for cuts, cracks or discoloration on the steering pad outer surface and in the grooved portion.
 - Check for cuts and cracks in the wire harness, and chipping on the connectors.
 - Check for deformation on the steering wheel.
 - Check for deformation of the steering pad contact plates.

If any of the defects mentioned above are present, replace the steering pad assembly with a new one.

- If the steering pad contact plates are deformed, never repair them. Always replace the steering pad assembly with a new one.
- There should be no interference between the steering pad and steering wheel, and the clearance should be uniform all the way around when the new steering pad is installed on the steering wheel.
